Preservation and Surface Characteristics

John Senger, P.E.
Illinois Department of Transportation

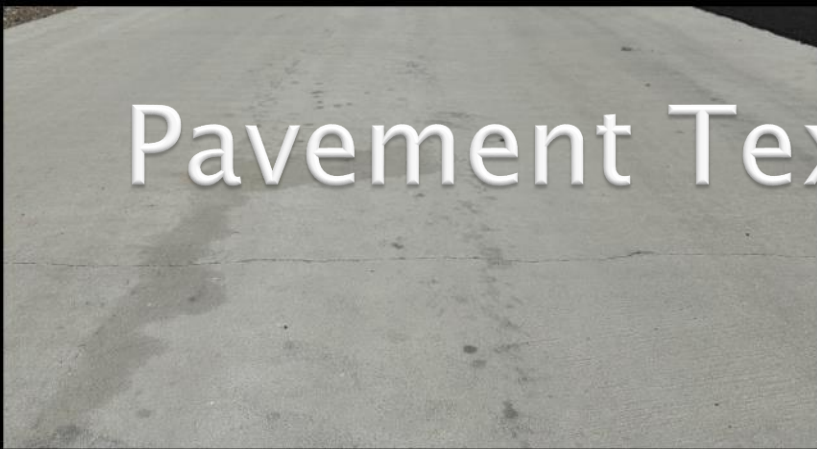
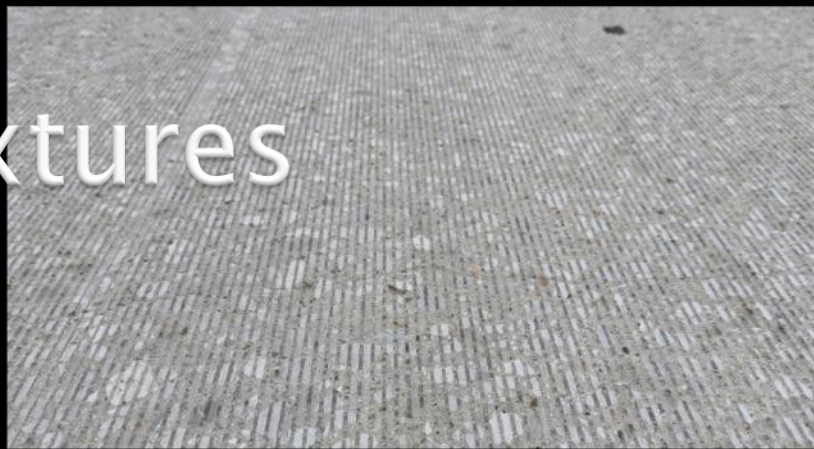
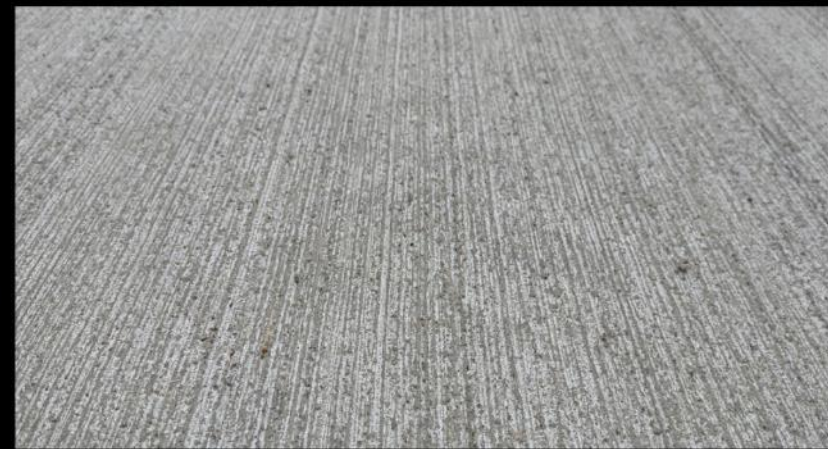
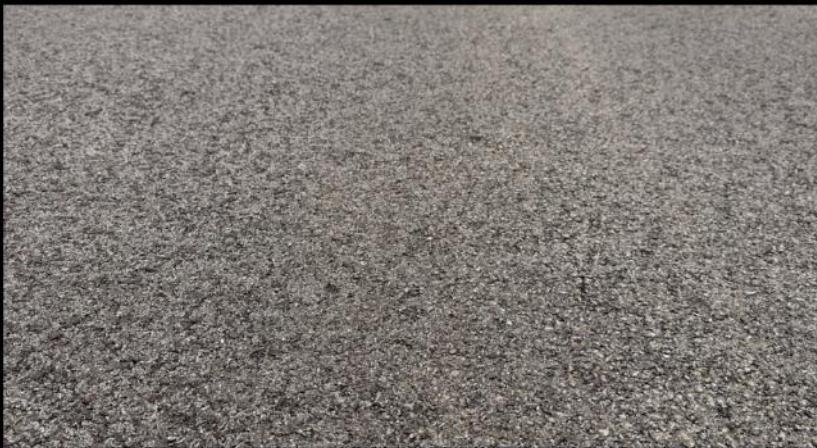
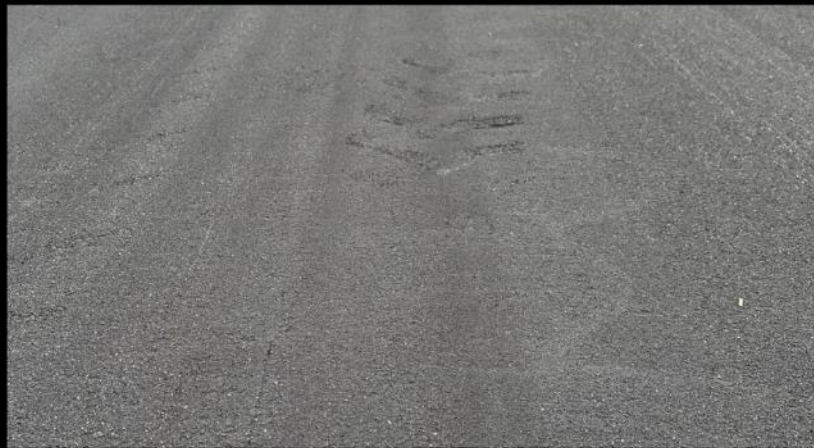
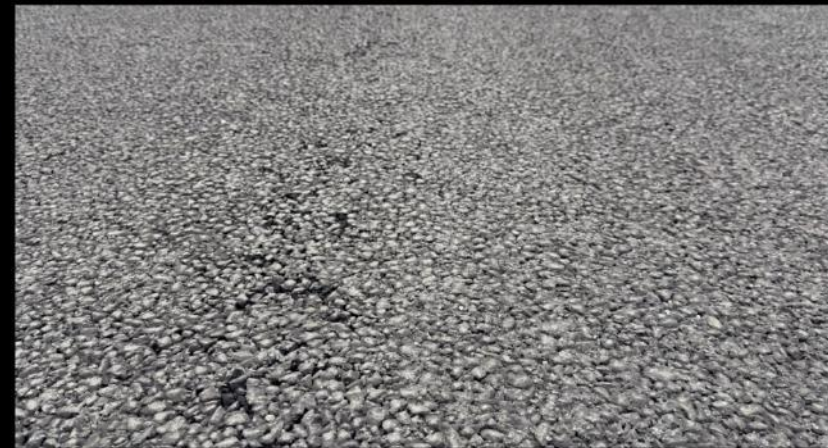
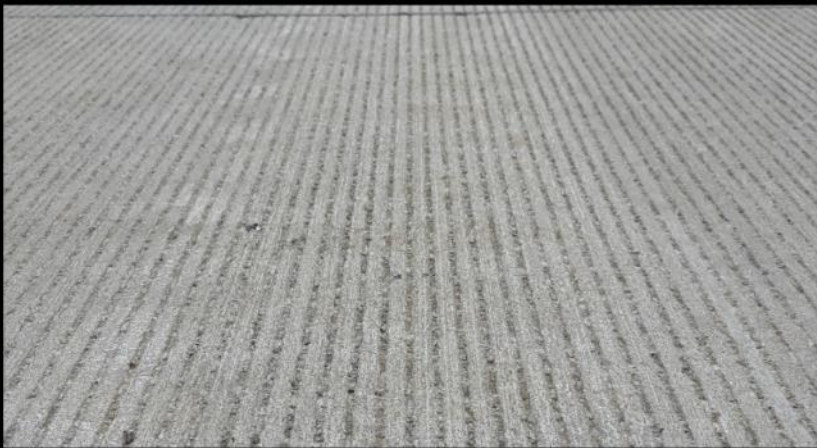
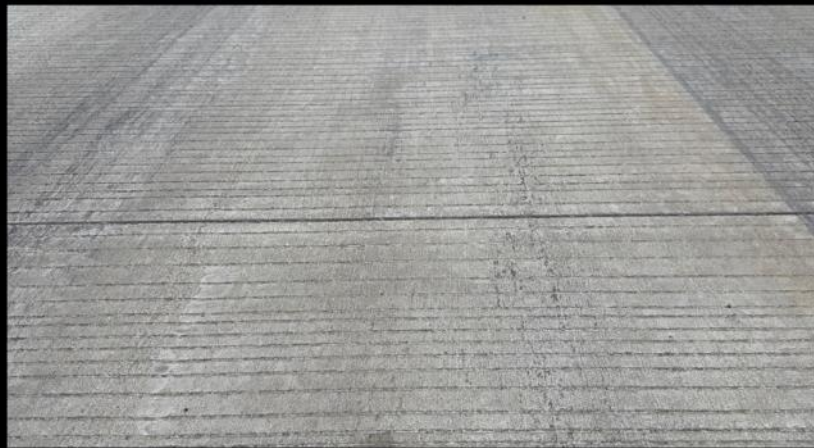
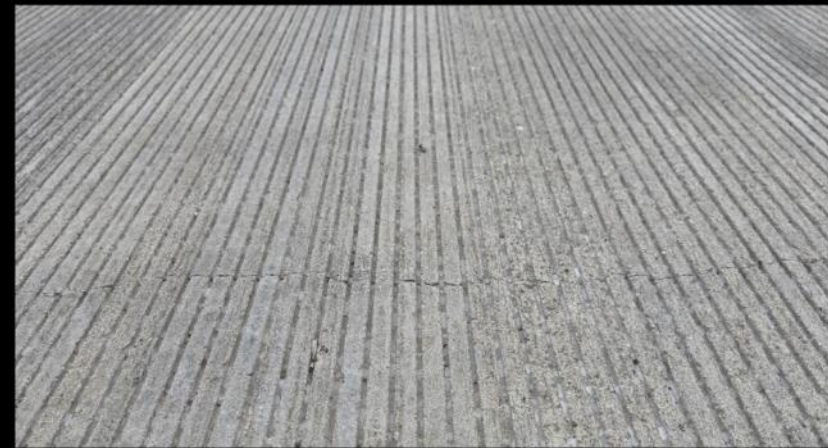
Pavement Textures

9.5 MM Dense Grade HMA

Friction	Ribbed Tire	50–55
	Smooth Tire	35–40
Macrotexture		0.55 mm
IRI Values		35–40 in./mi.

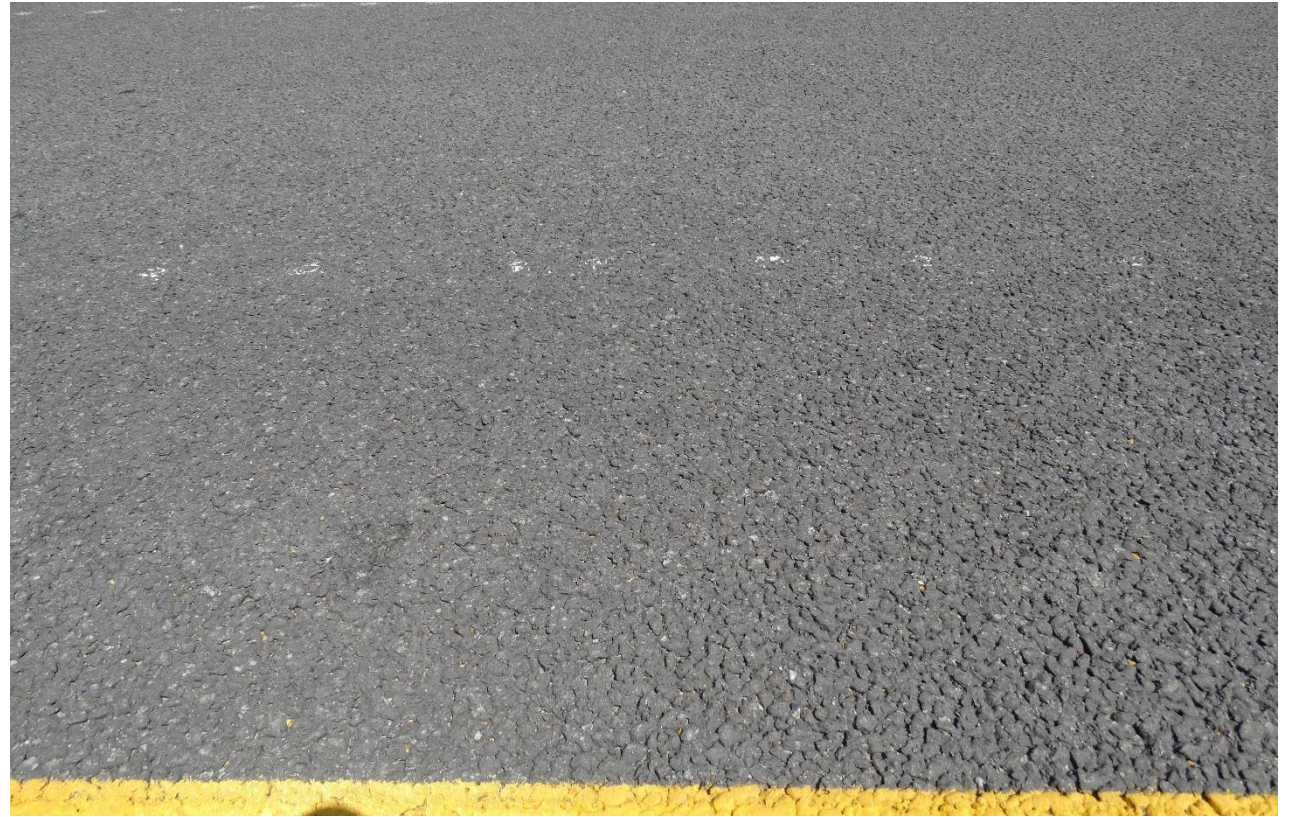
ICART – Lane 2

12.5 MM Stone Matrix Asphalt

Friction	Ribbed Tire	50–55
	Smooth Tire	40–50
Macrotexture		1.3 mm
IRI Values		40–50 in./mi.

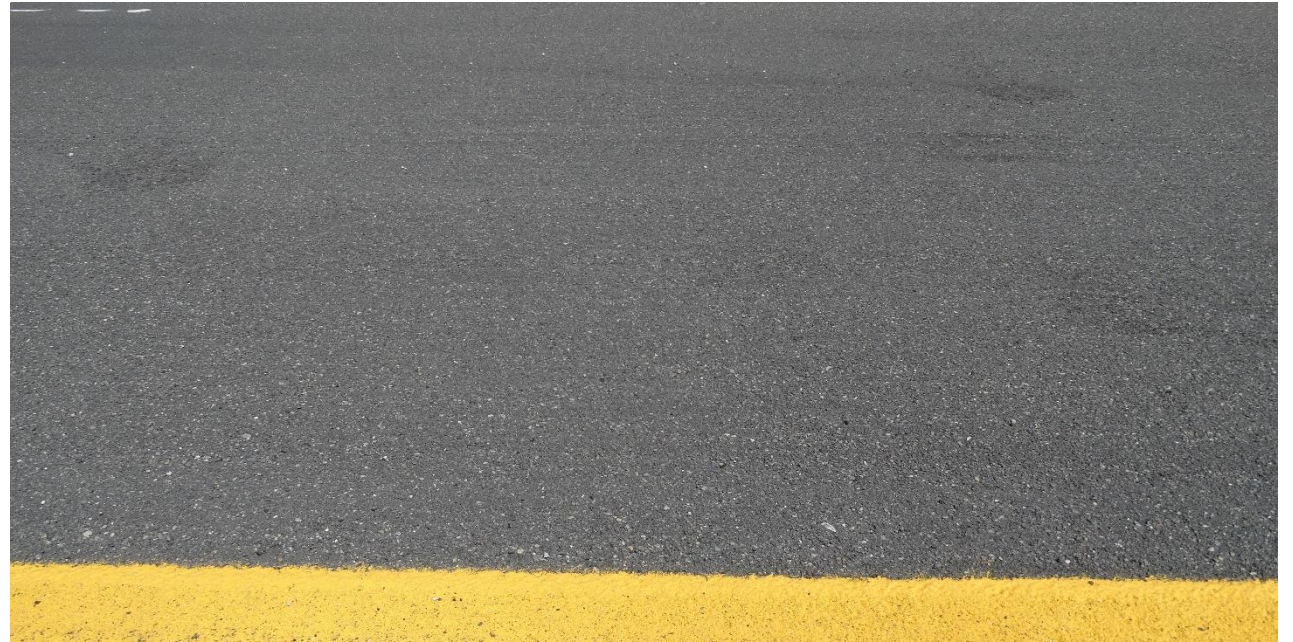
ICART Lane 2

Micro surfacing (30% Calcined Bauxite & 70% ACBF Slag)

Friction Ribbed Tire 60-70
 Smooth Tire 50-60

Macrotexture 0.45 mm

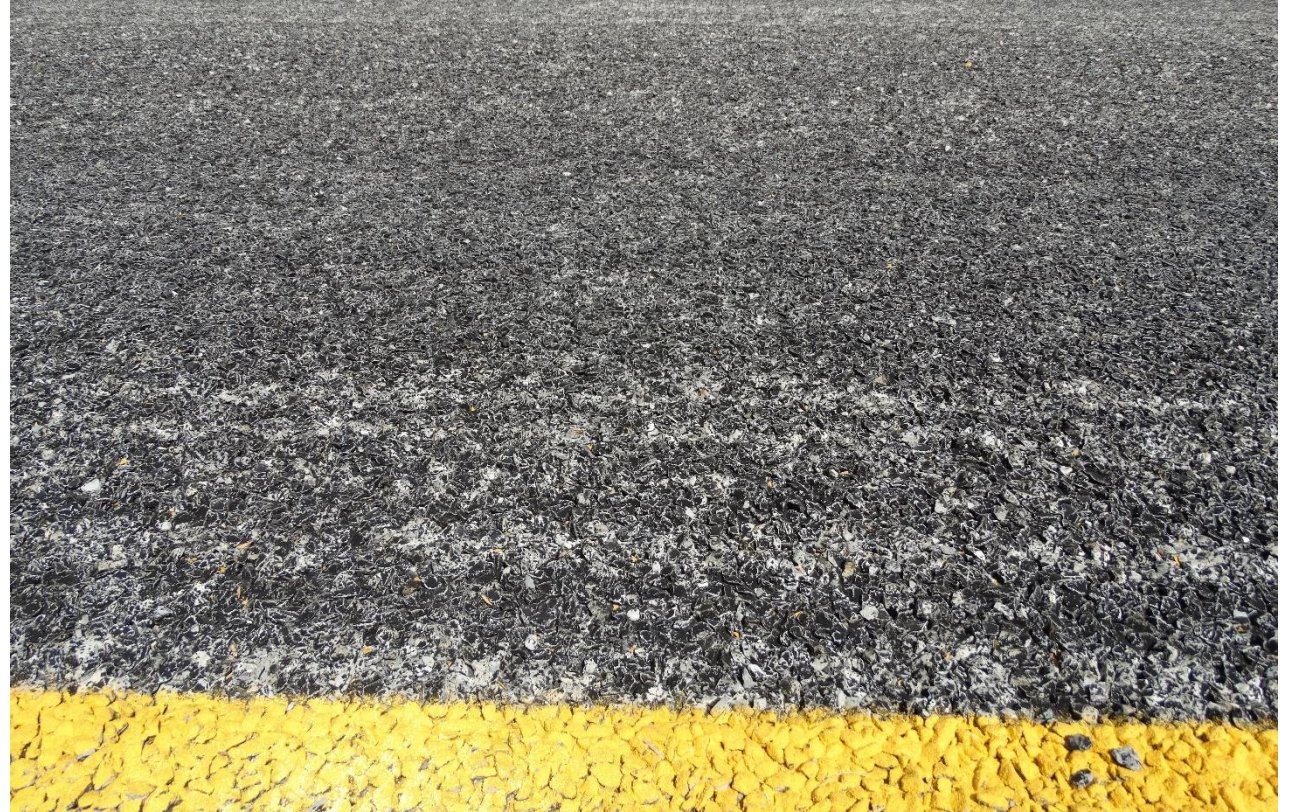
ICART Lane 2

CA 15 Chip Seal

Friction Ribbed Tire 60–70
 Smooth Tire 50–60

Macrotexture 2.83 mm

Note: Only tested once with two units
at 30, 40, and 50 MPH

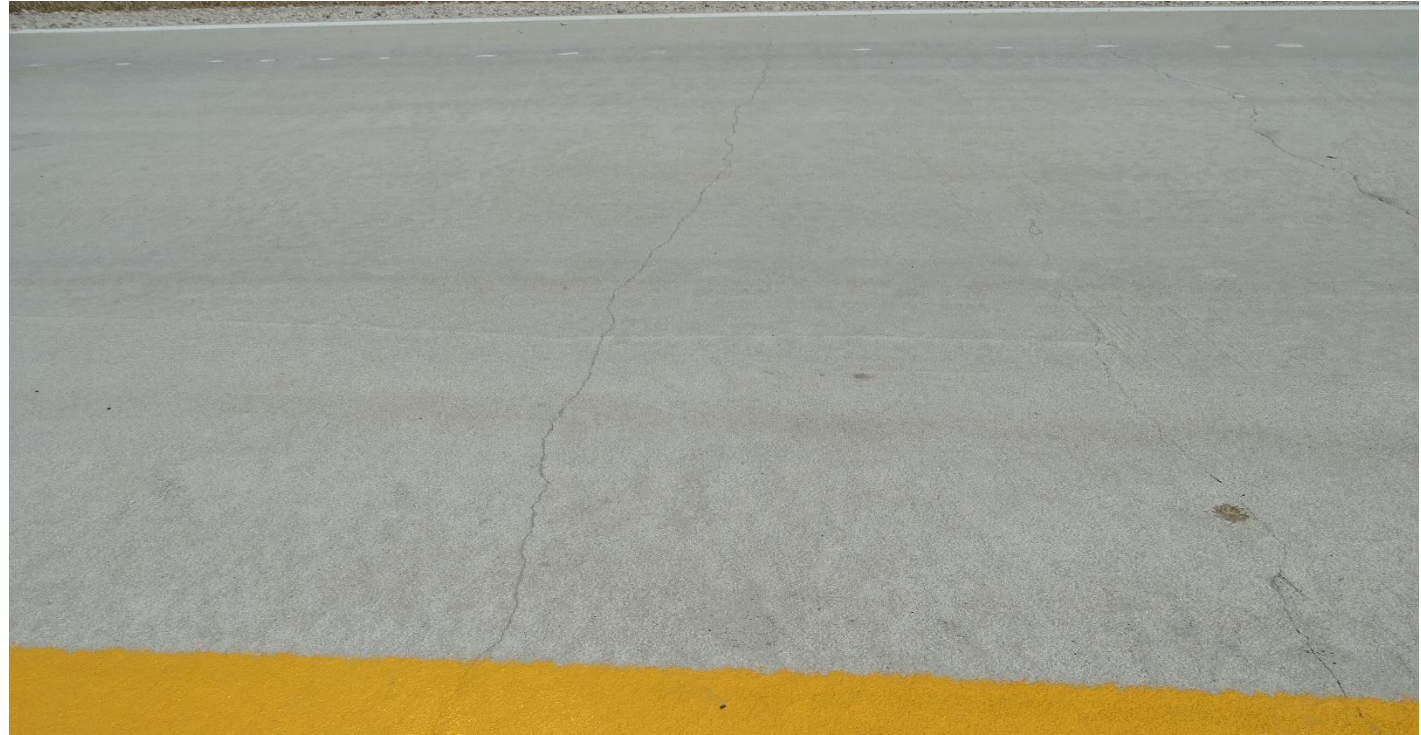
ICART Lane 1

PCC with no texturing

Friction	Ribbed Tire	44.5
	Smooth Tire	25.4
Macrotexture		0.16 mm
IRI Values		37 in./mi.

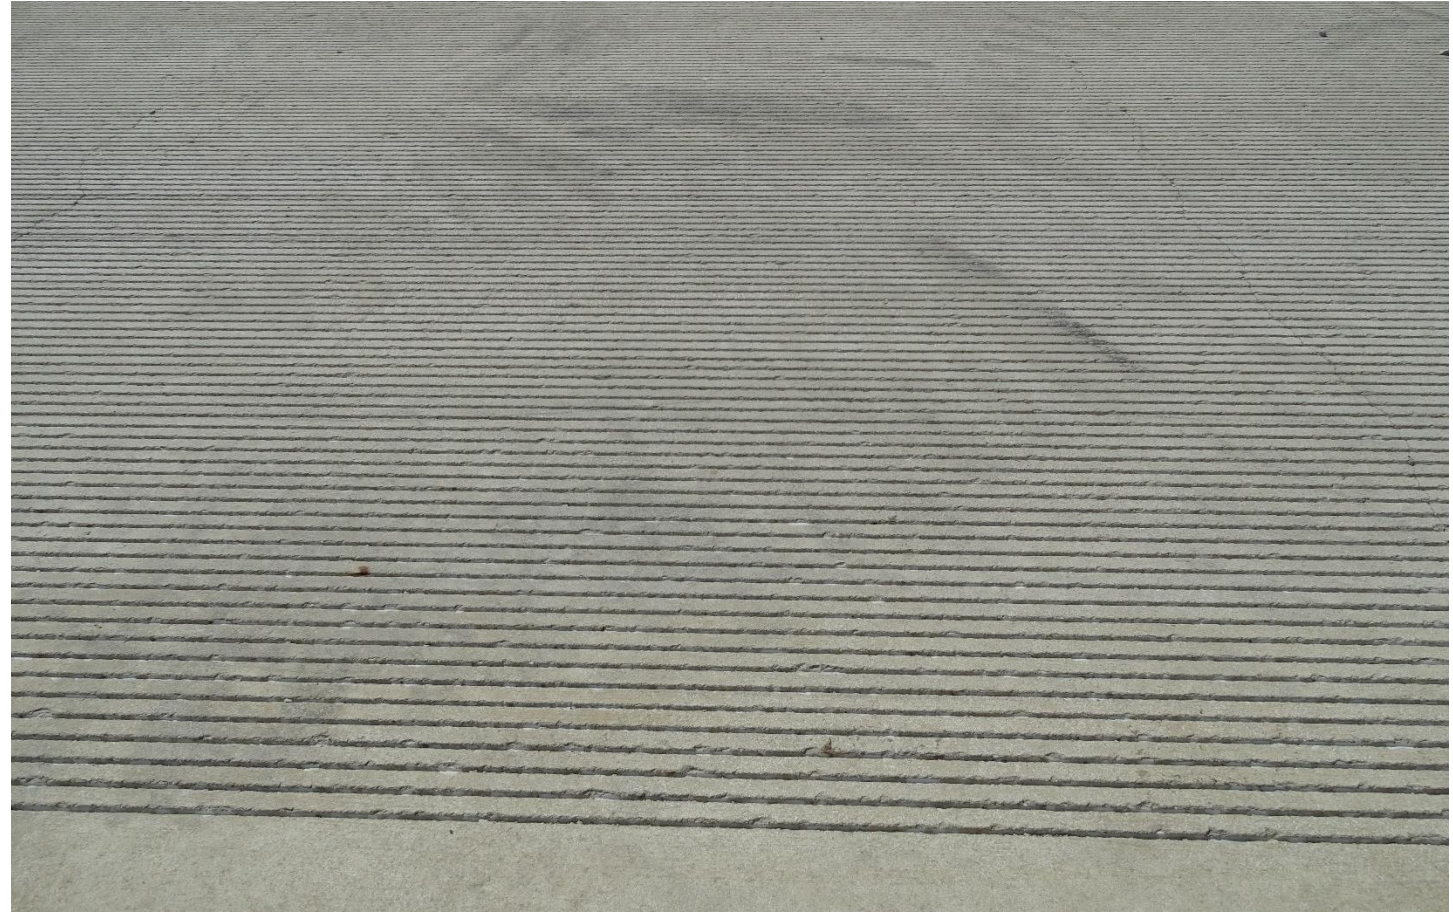
ICART Lane 1

Smooth PCC with Diamond Grooving

Friction	Ribbed Tire	55
	Smooth Tire	58
Macrotexture		0.93 mm
IRI Values		40 in./mi.

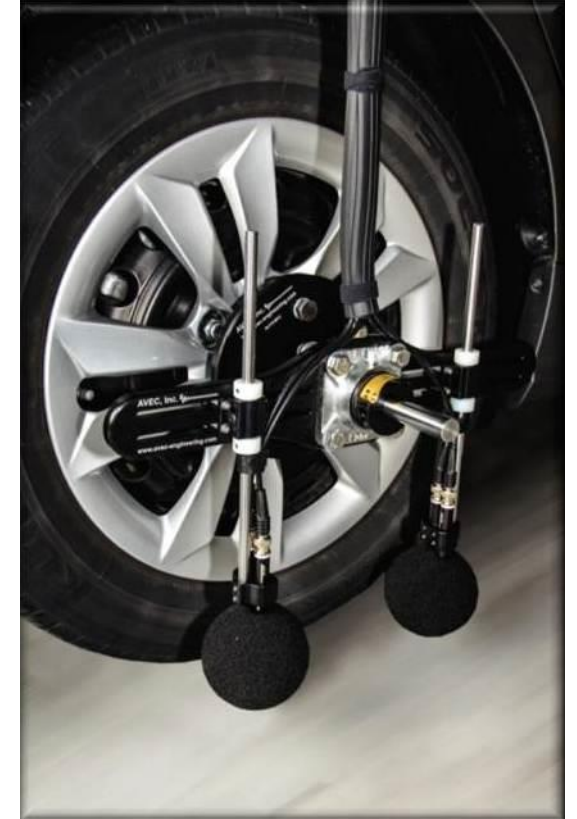
- ▶ Tire-pavement noise is usually measured with OBSI system
- ▶ Noise is generated from the pavement surface macrotexture
- ▶ Tire-pavement noise transmission can be affected by absorption and void structure
- ▶ Negative and Positive Macrotexture
- ▶ Often confused with roughness

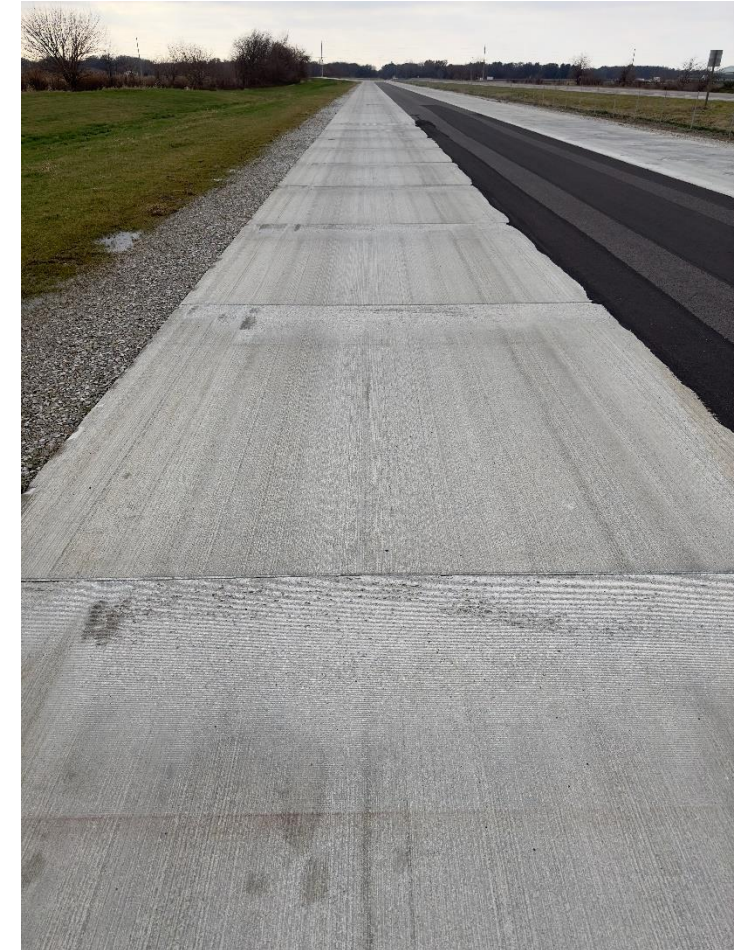
Transverse faulting occurs when eroded or infiltrated materials build up under the approach side of the joint or crack and a corresponding depression occurs under the leave side.

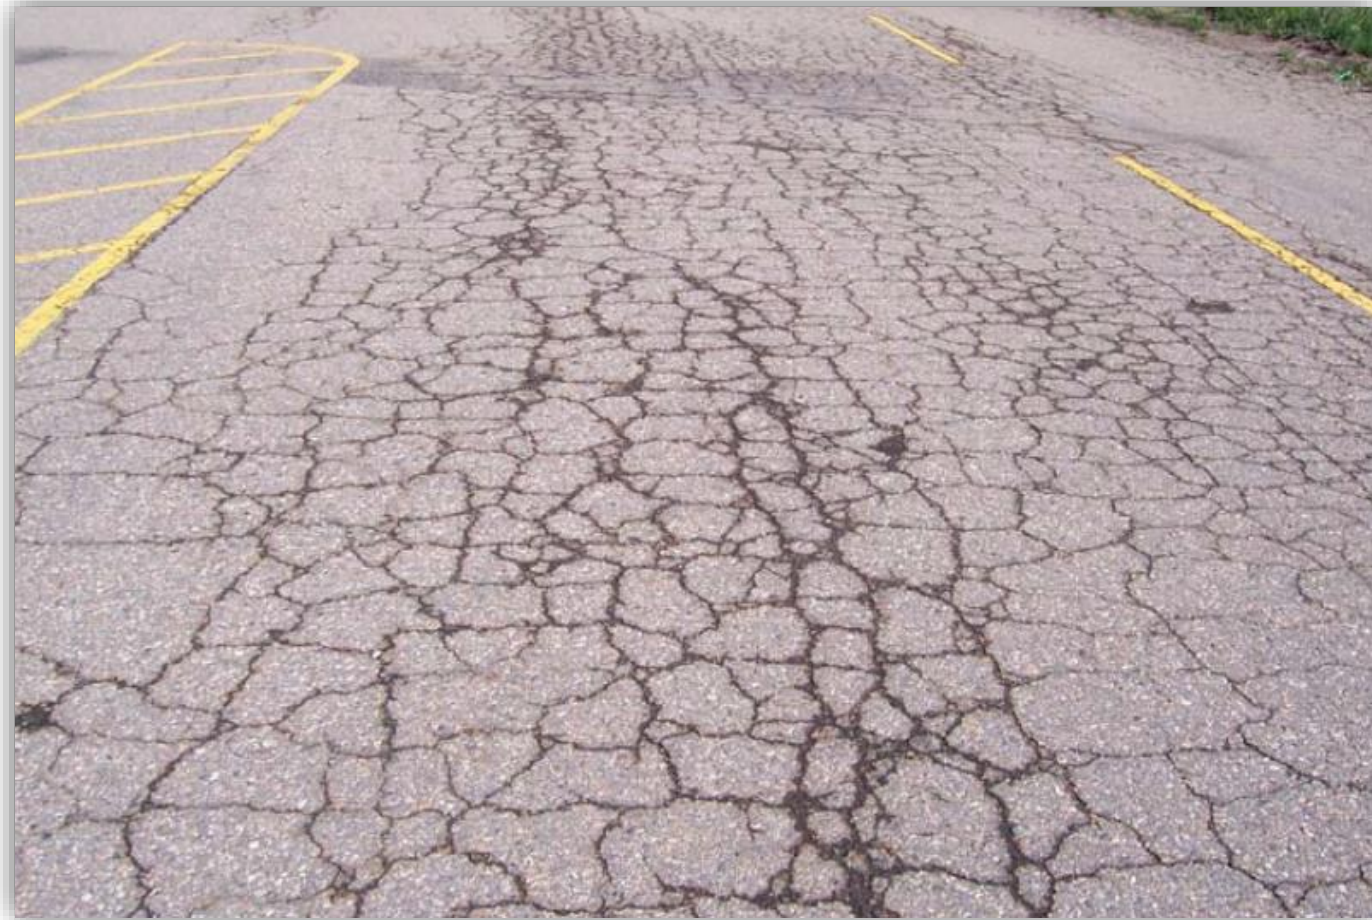
Cracking

- ▶ Transverse
- ▶ Longitudinal
- ▶ Functional
- ▶ Structural

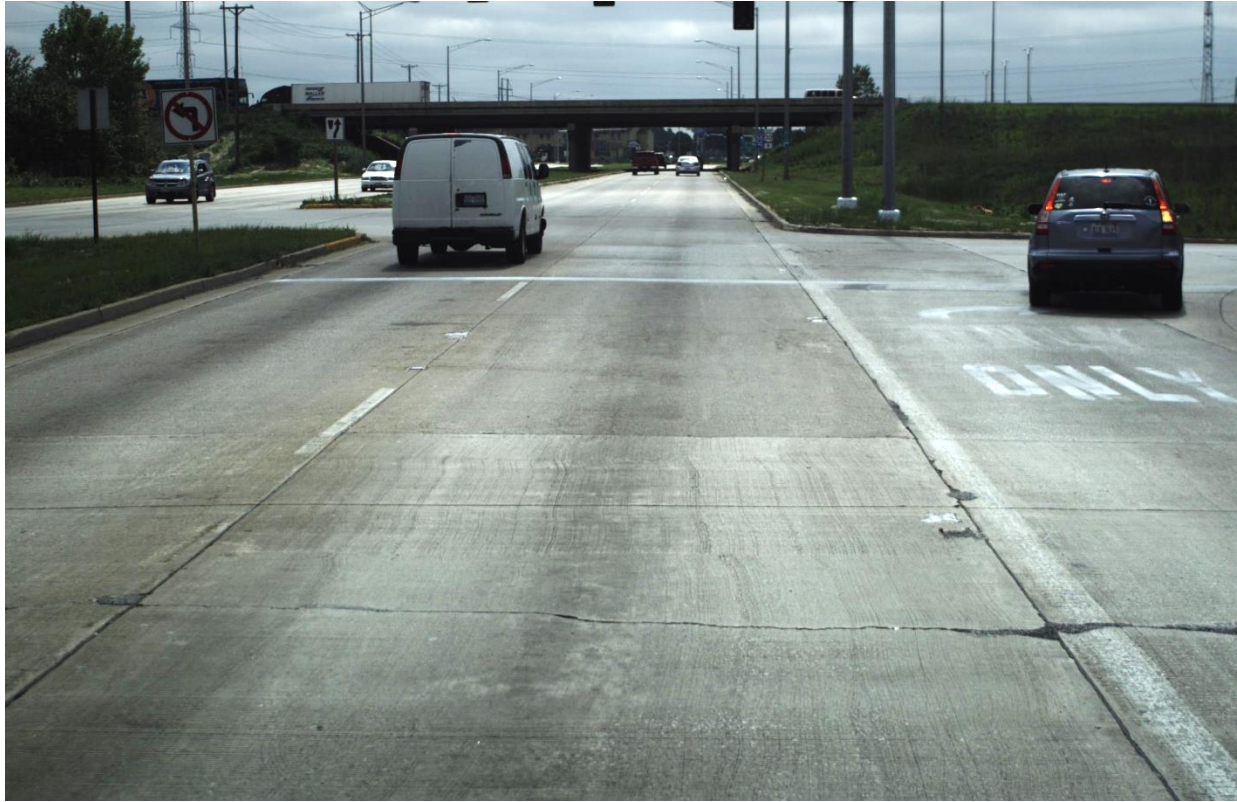
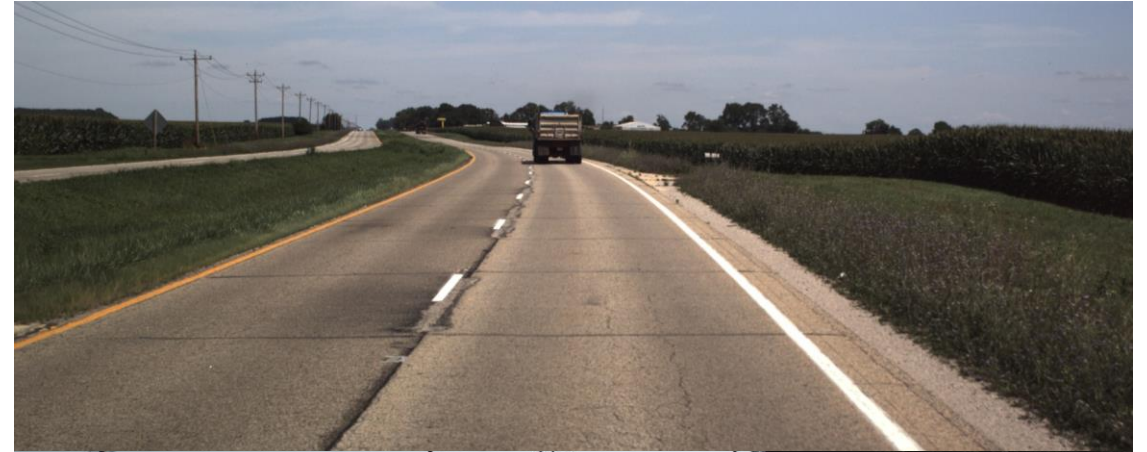
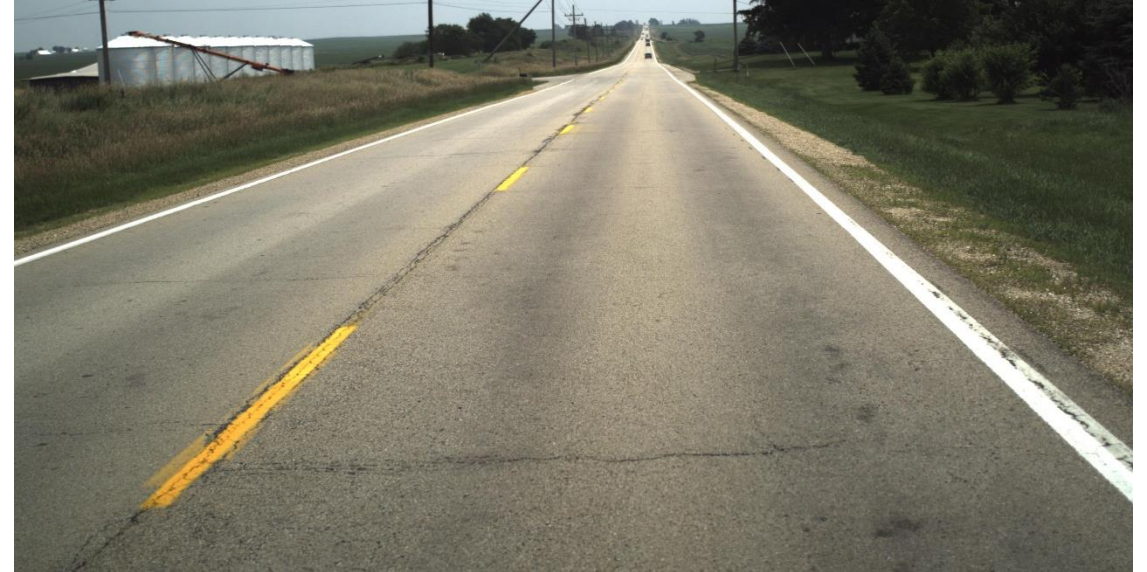
Transverse Cracking

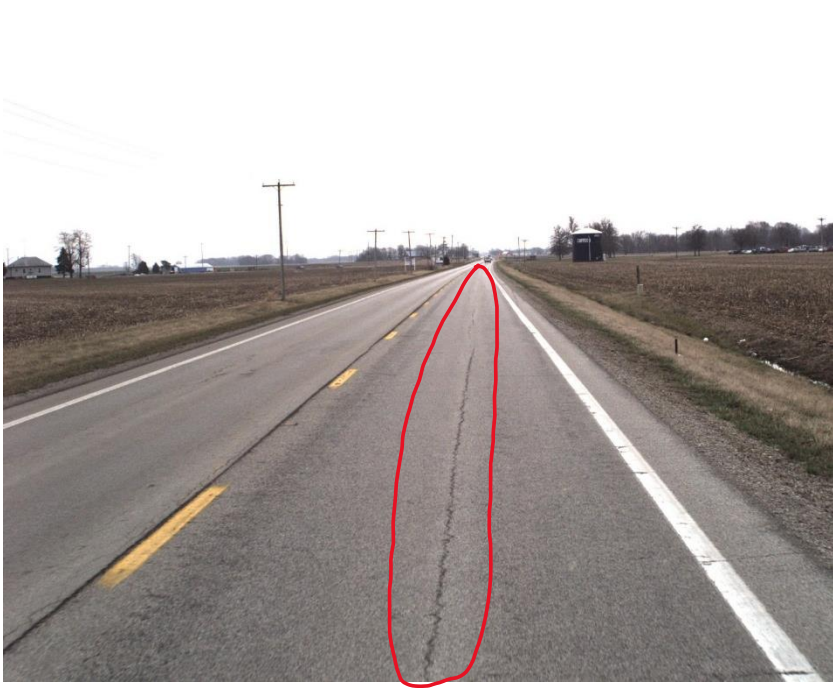
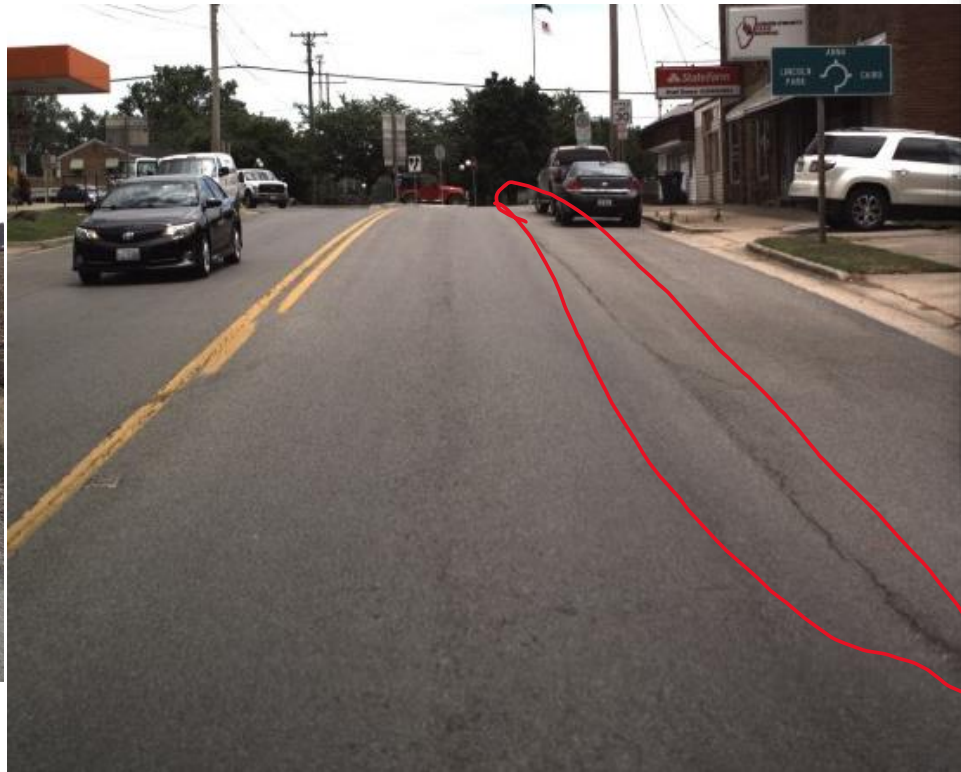
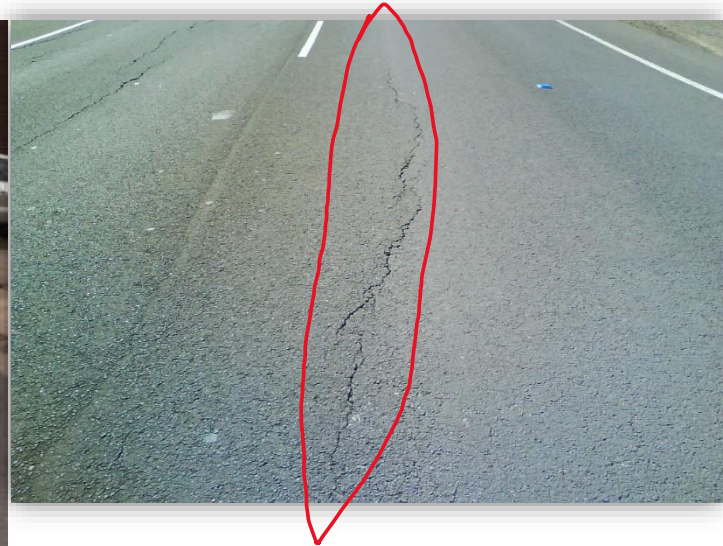
Longitudinal Cracking

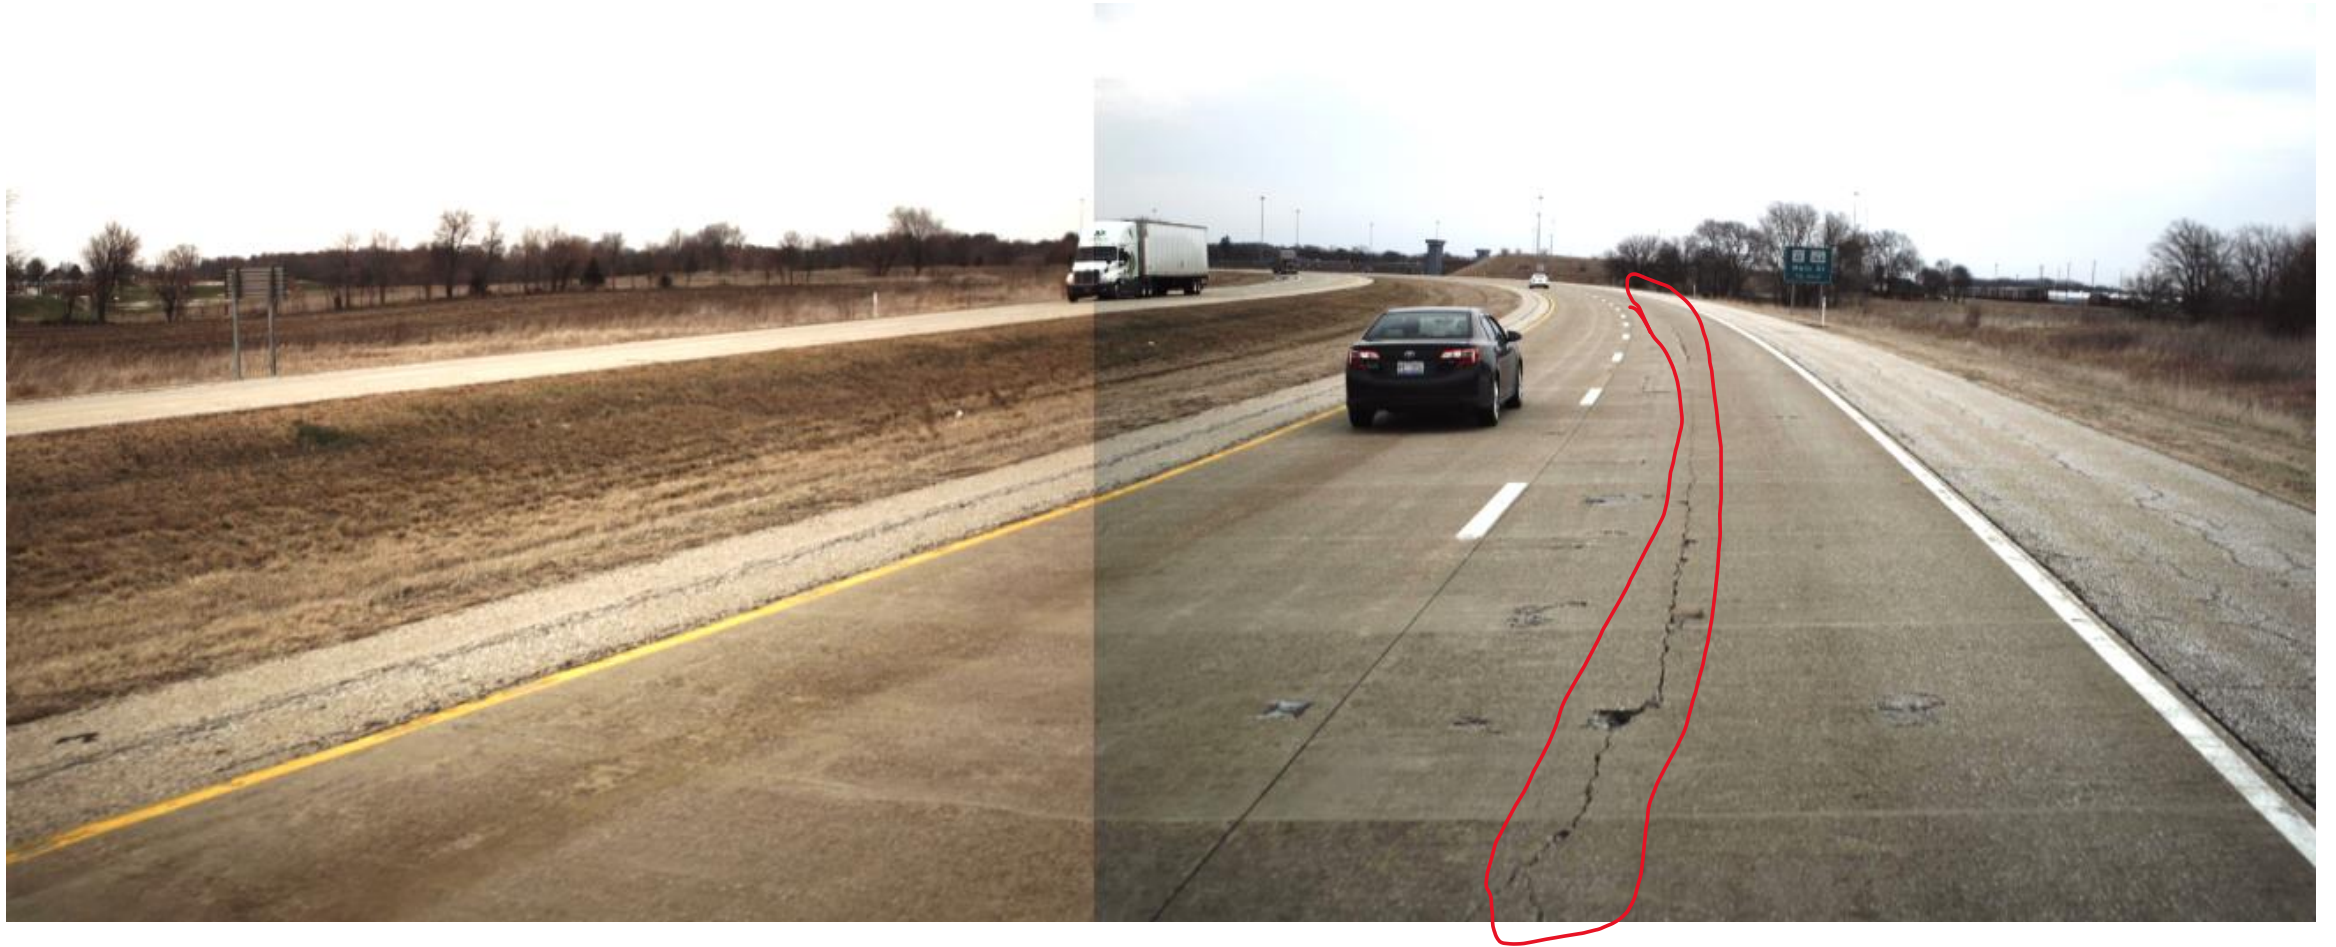
PCC Longitudinal Cracking

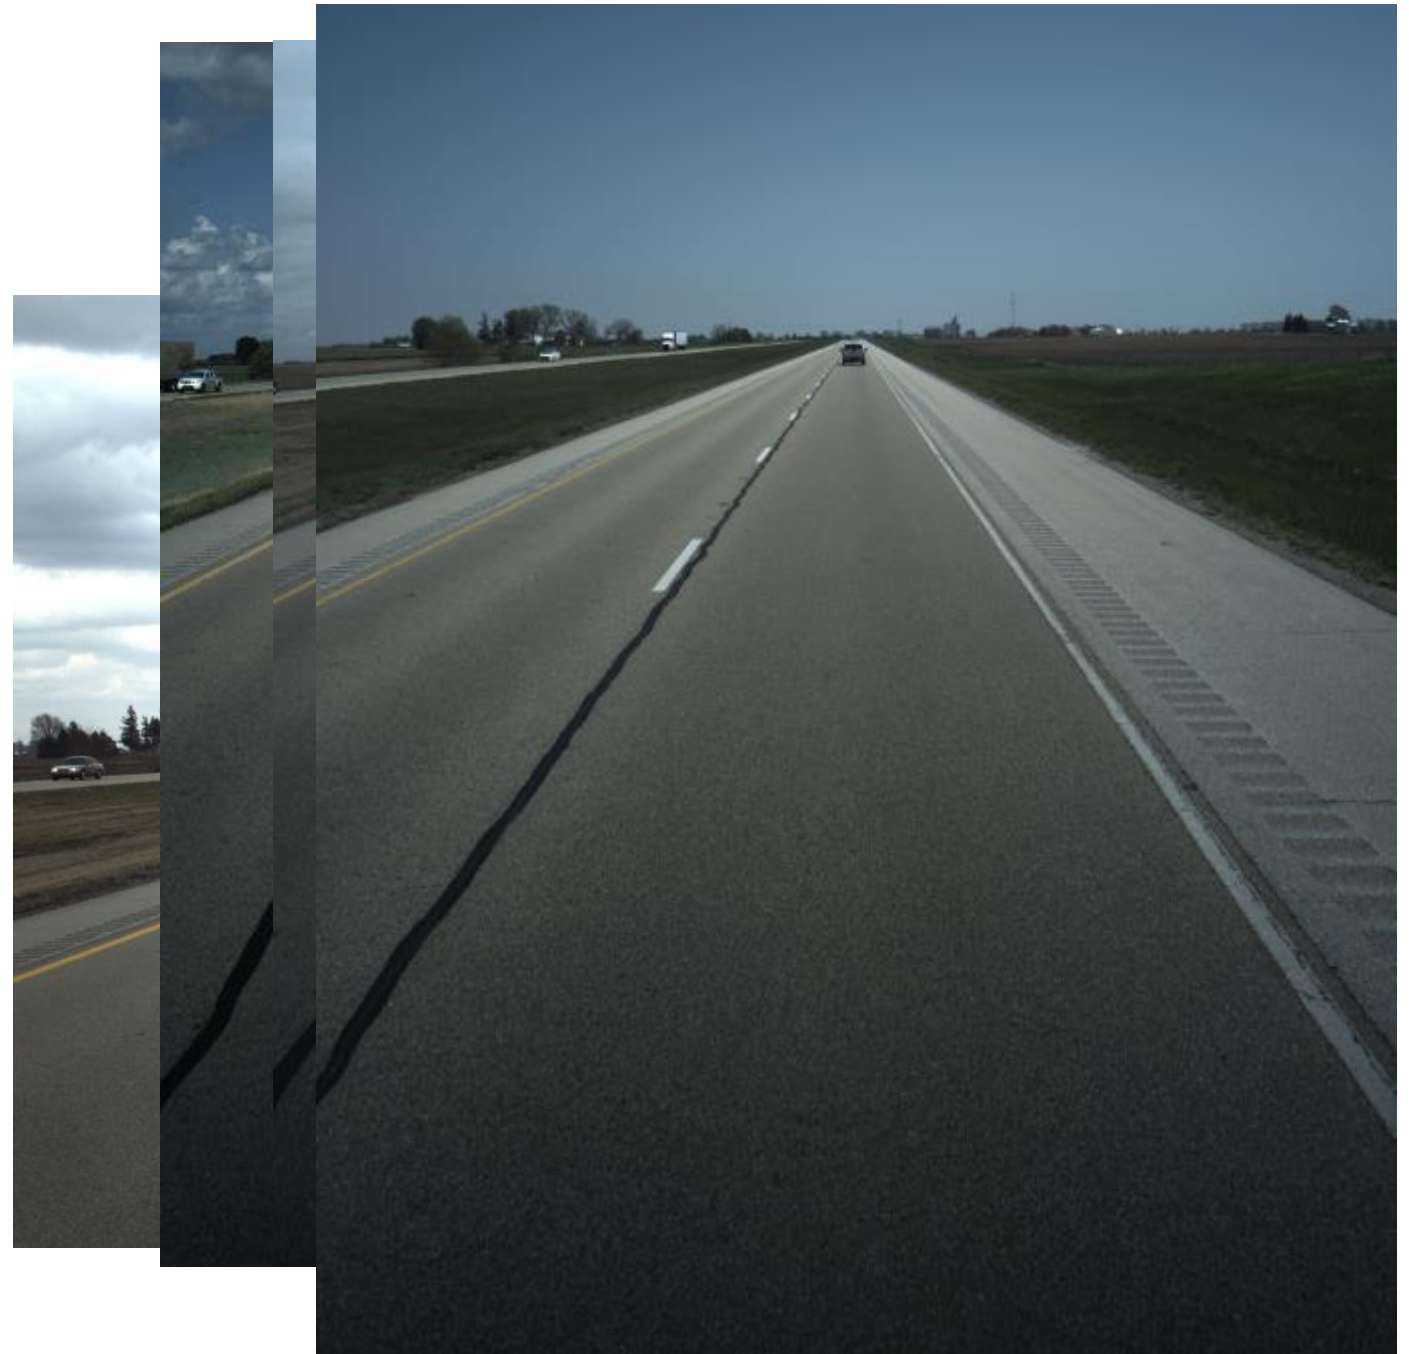
I-55 on the north side of Lincoln, IL

Structural Overlay placed in 2015

First photo was taken during our inventory collection in 2016
