# AASHTO TSP2 BRIDGE PRESERVATION SCOUR

**Scour is the number 1  
cause of bridge failure  
in the  
United States**

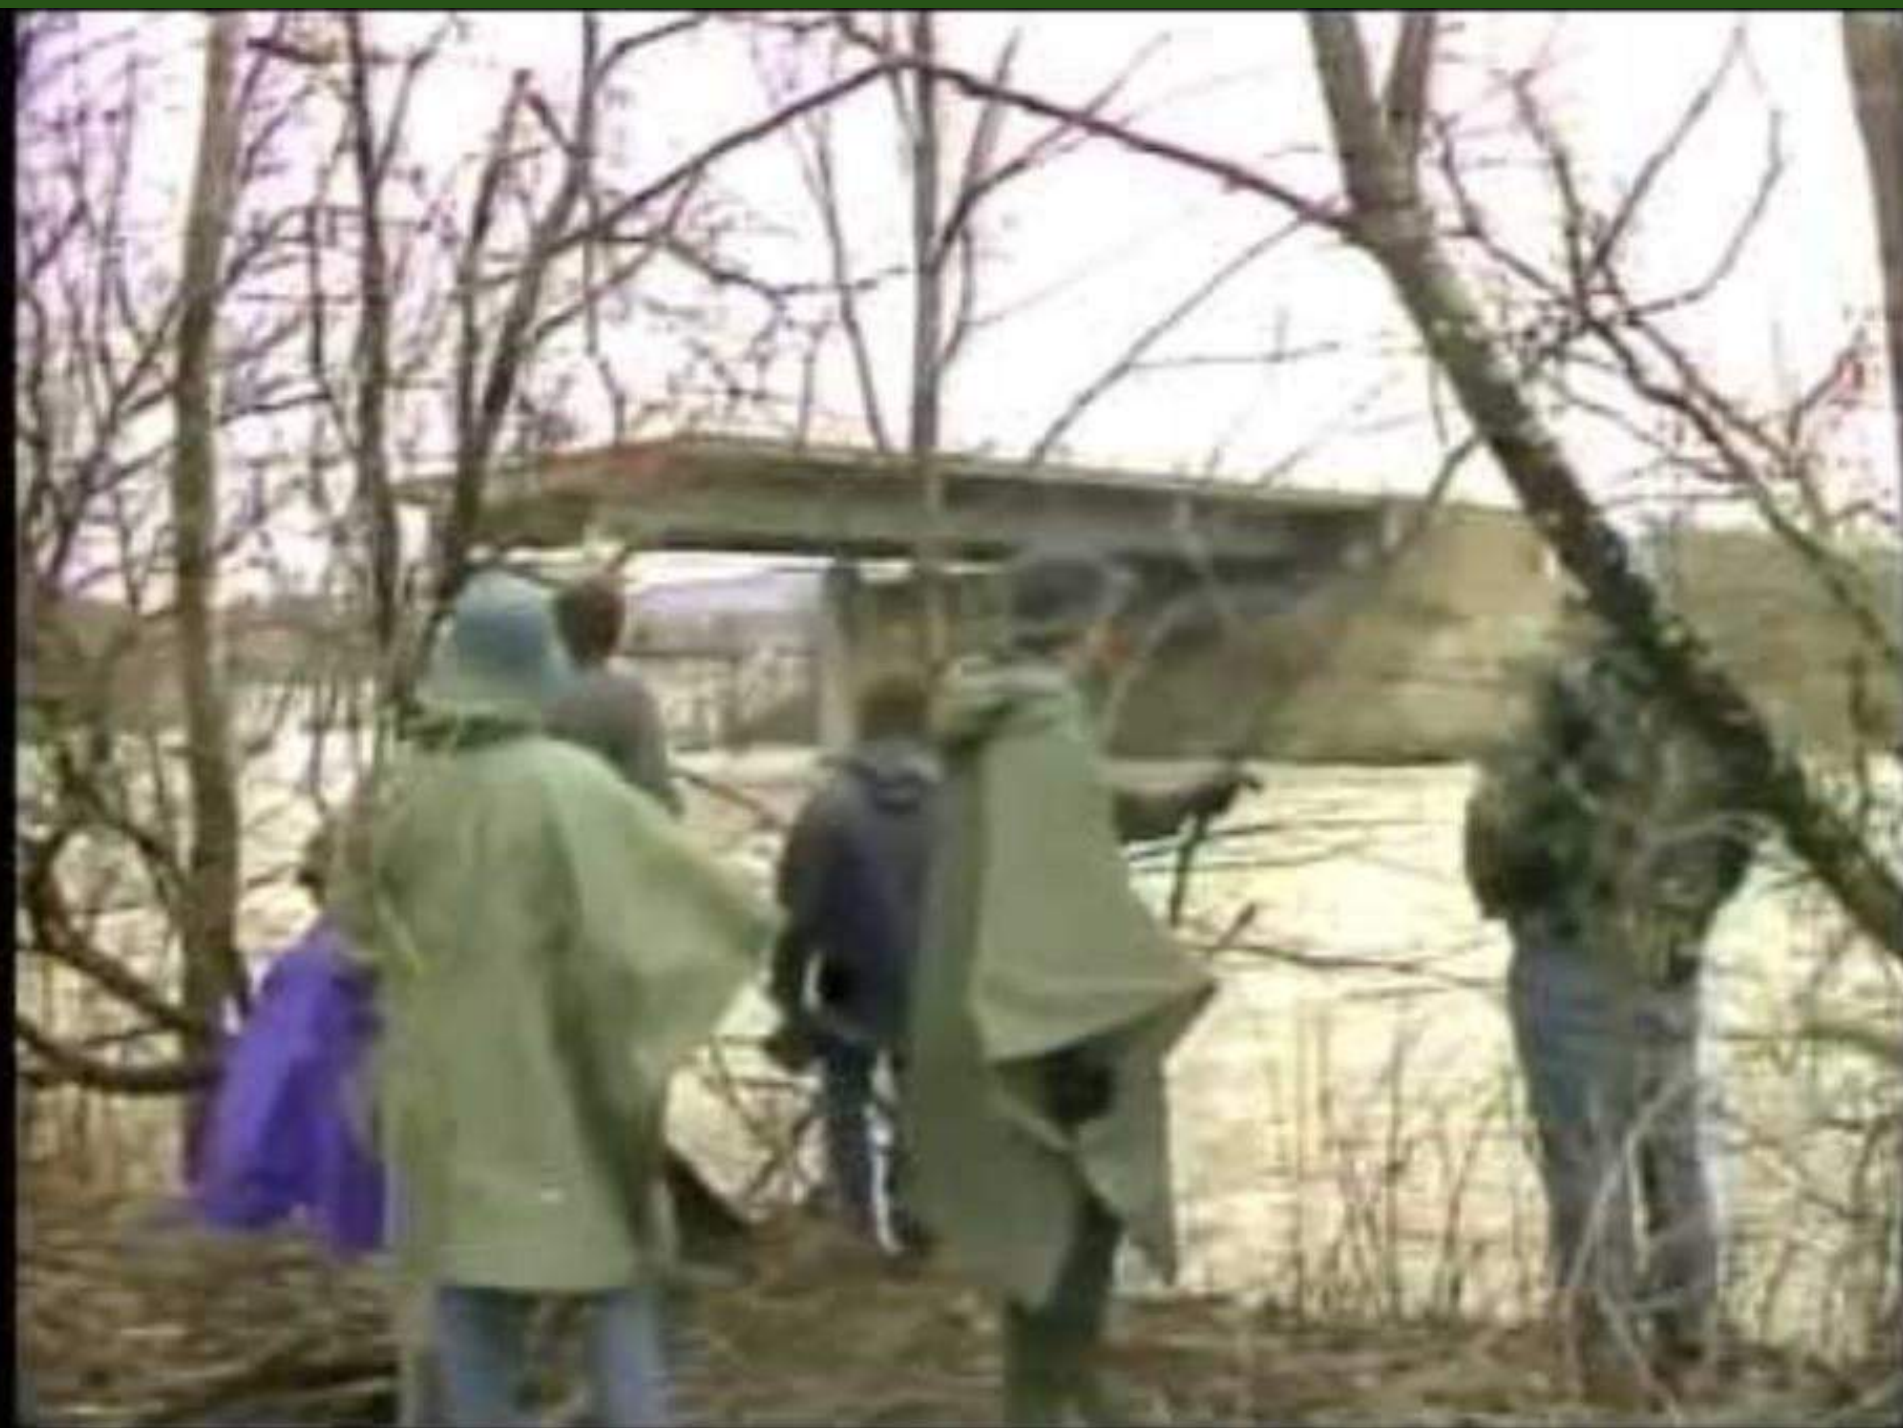
In April 1987, a catastrophic failure of the Schoharie Creek Bridge on the New York State Thruway claimed 10 lives

The National Transportation Safety Board determined that the probable cause was severe **scour** beneath the **spread footings** of the 35-year-old bridge.

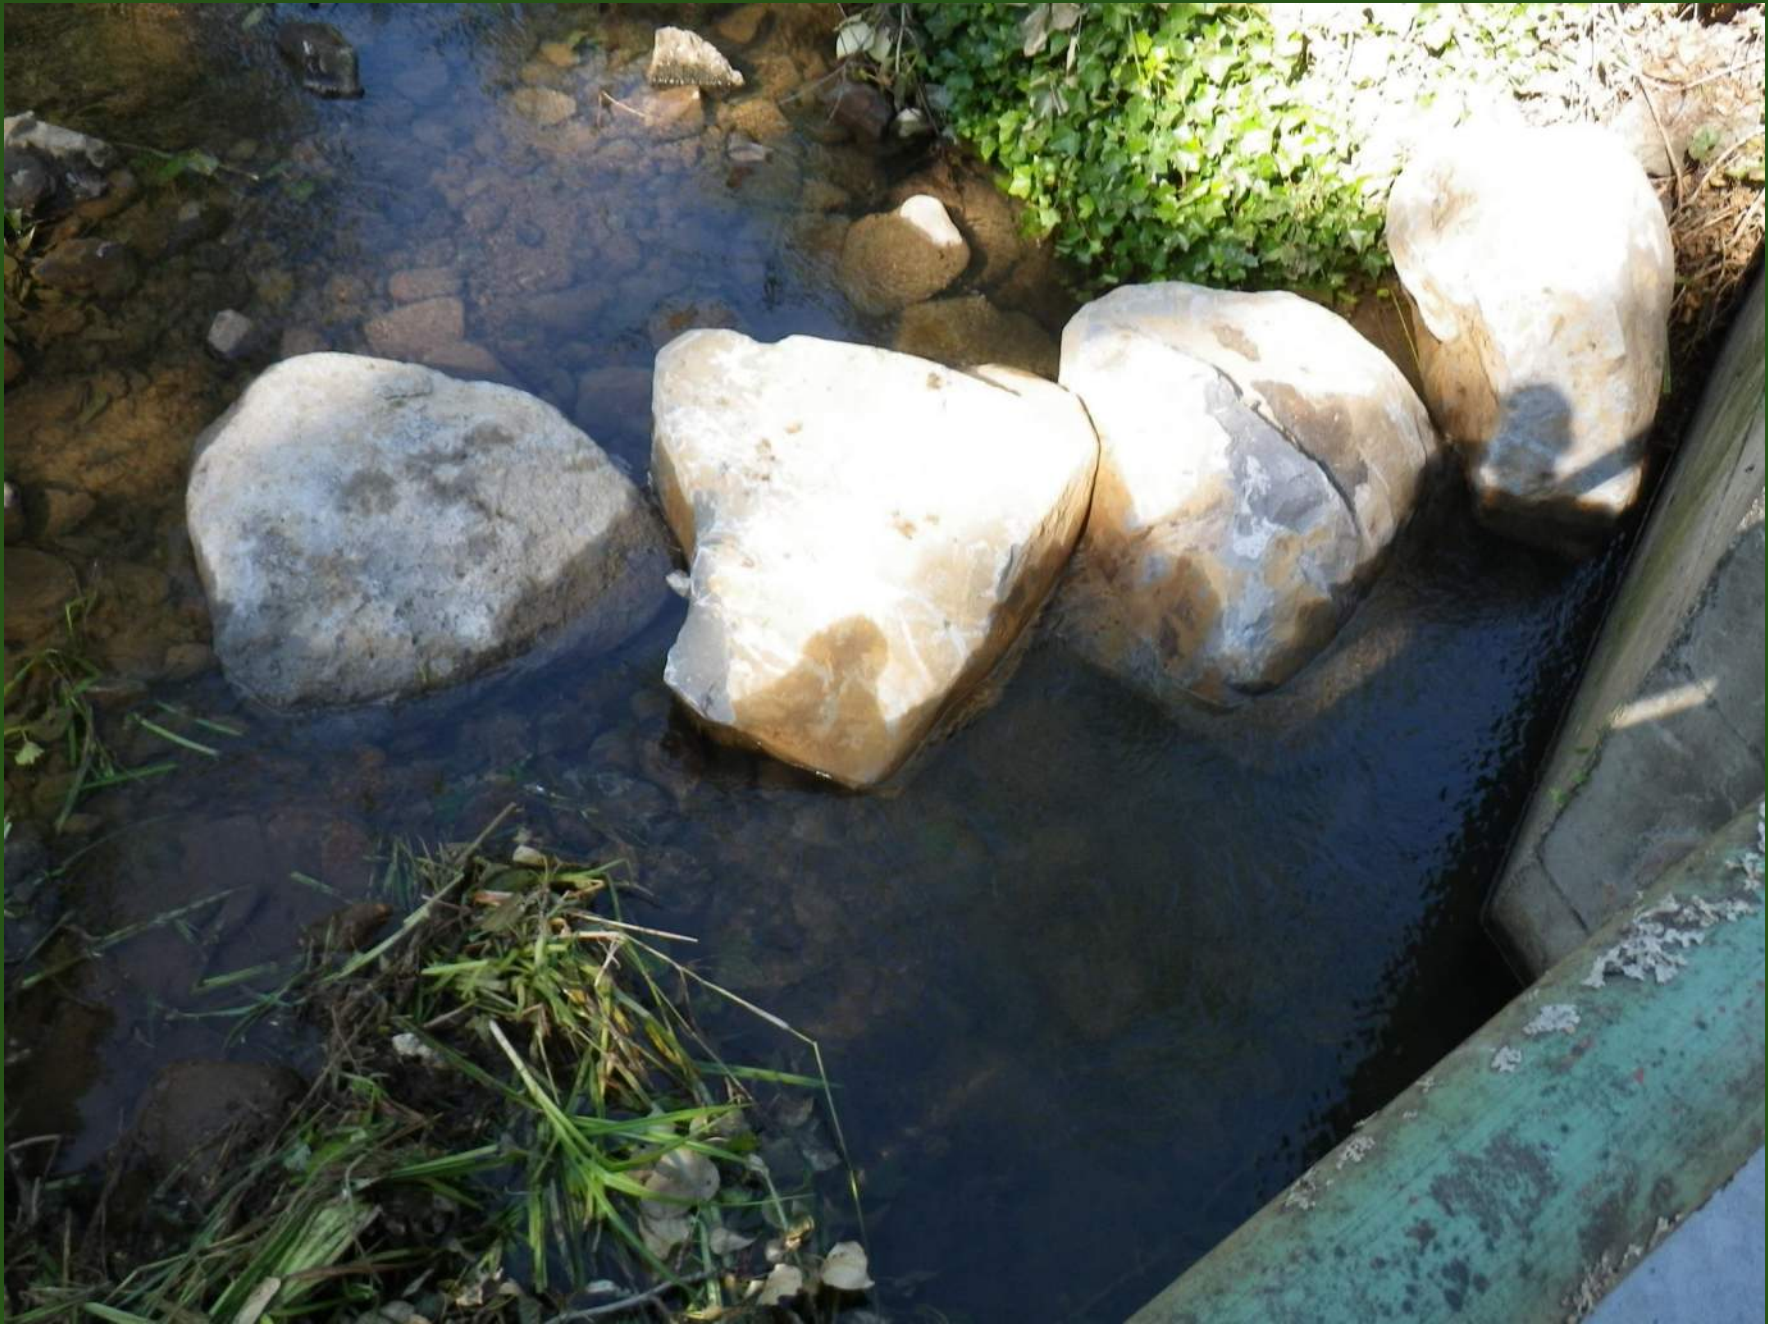
WATER FLOW DIFFUSER,  
6" PVC WITH 3/4"  
HOLES AND PLASTIC  
SHEETING

DISCHARGE LINE

COFFER DAM  
FISH NET

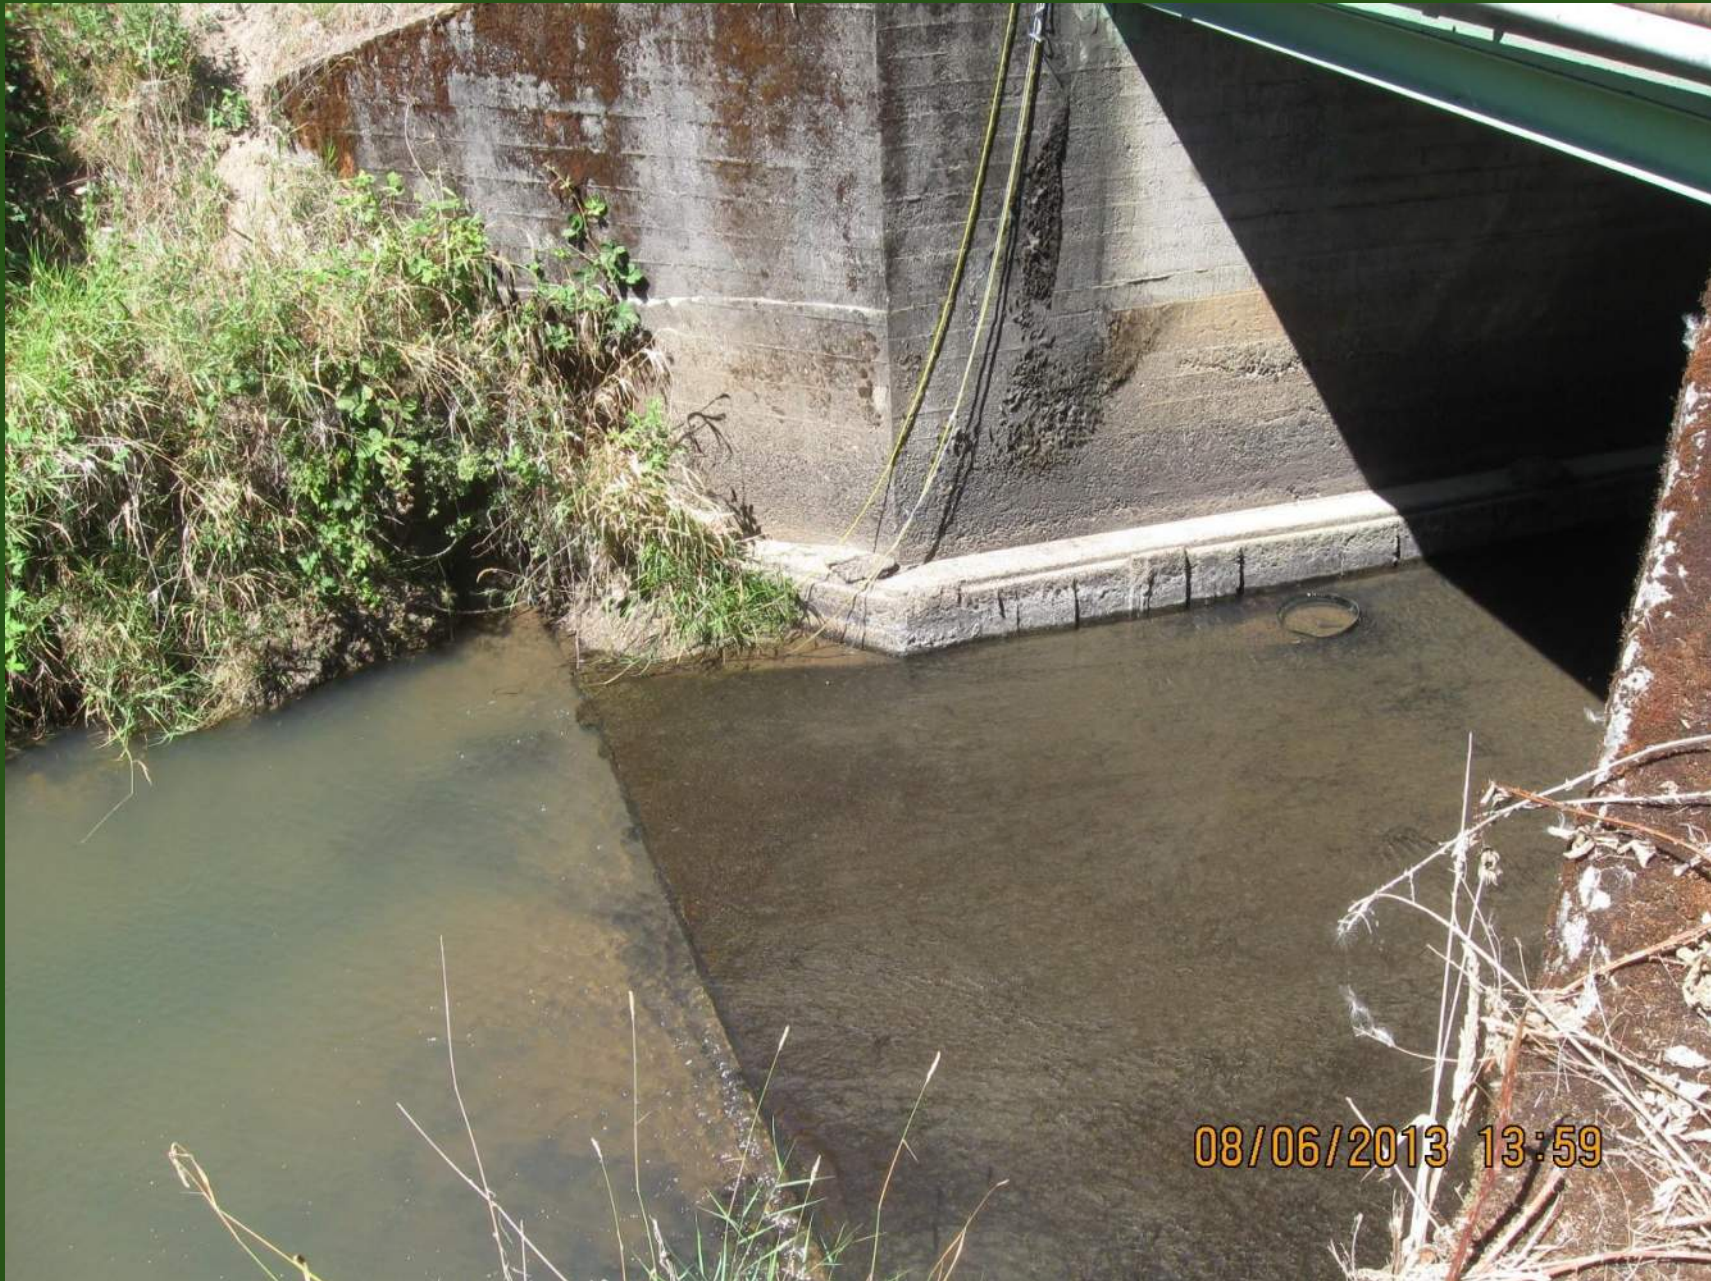
60' ROAD  
RIGHT OF WAY

CONCRETE HEADWALLS
